PERFORMANCE OF CEMENT CLAY INTERLOCKING HOLLOW BRICK MASONRY WALLS SUBJECTED TO DIAGONAL COMPRESSION

PANUWAT JOYKLAD^{1,*}, QUDEER HUSSAIN²

Abstract

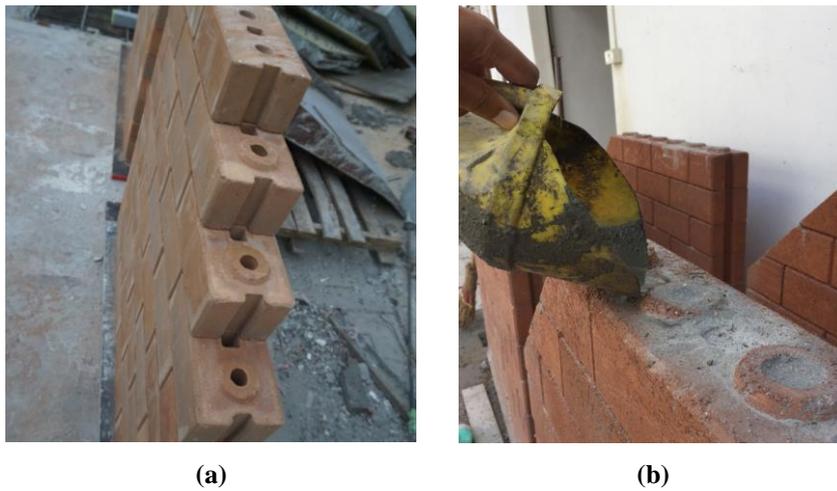
Fig. 1. Typical construction details of masonry walls.

In this study, five CCI hollow brick masonry walls were constructed and tested under diagonal compression. The details of test matrix are summarized in Table 1. Masonry wall specimens of dimensions 1000×1000×125 mm were constructed from CCI hollow bricks of 250×125×100 mm using running bond pattern as shown in Fig. 1. This size was basically adopted to meet the requirements of lab facilities such as capacity of hydraulic jack, load cell and reaction frame. In the masonry wall specimen W1, the layers of CCI hollow bricks were dry stack without using any mortar or grout as shown in Fig. 2(a). The wall specimens W2-O and W3-N were grouted with OPC - sand grout and HPNSC - sand grout, respectively, Fig. 2(b). The last two walls, i.e., W4-O-R and W5-N-R were also grouted with OPC - sand grout and HPNSC - sand grout, respectively, however, prior to the grout filling, round steel bars of diameter 9 mm were also inserted into the holes of CCI hollow bricks at the end locations and middle as shown in Fig. 3. The masonry wall specimens were named according to the following convention: In wall specimen W4-O-R, W4 is wall number (Number 4), O is representing grout of OPC - sand grout, and last digit R is reinforcement. The CCI hollow brick masonry walls constructed in this experimental program are shown in Fig. 4.

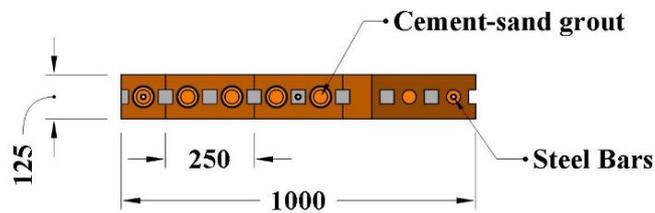
Fig. 2. Typical constructions of CCI brick masonry walls.

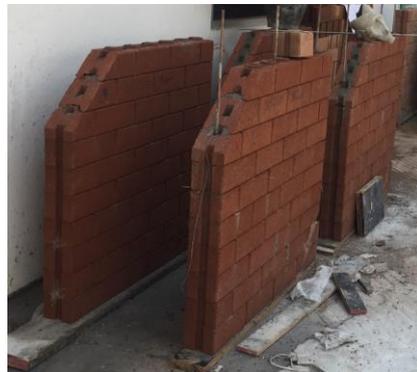
Fig. 3. Details of masonry walls.

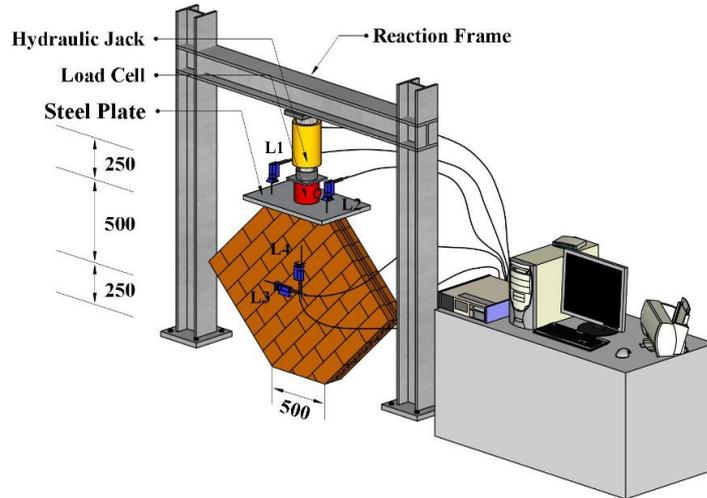
In this research, the CCI hollow brick masonry walls were tested under the diagonal compression in the reaction frame having a capacity of 2000 kN. The diagonal compressive load was applied using a hydraulic jack and load intensity was recorded through a calibrated load cell placed under the loading piston of the hydraulic jack. A steel plate (1000×200×20 mm) was placed at the top of the masonry wall to ensure the uniform distribution of the applied load. In addition, a thin layer (thickness = 5 mm) of high strength white cement was also provided at

the top of masonry wall (under the steel plate) to maintain a balance load transfer from steel plate to the masonry wall. The CCI brick walls were instrumented with four linear variable differential transducers (LVDTs) to measure the overall vertical diagonal deformation (L1 and L2), vertical shortening at the mid region (L3) and horizontal extension or lateral dilation of the masonry wall at mid region (L4). During the test, the initiation and propagation of cracks were visually inspected and recorded by photographs. Typical sketches of loading setup and instrumentation details are shown in Fig. 5.

Fig. 5. Loading setup and instrumentation detail (units in mm).

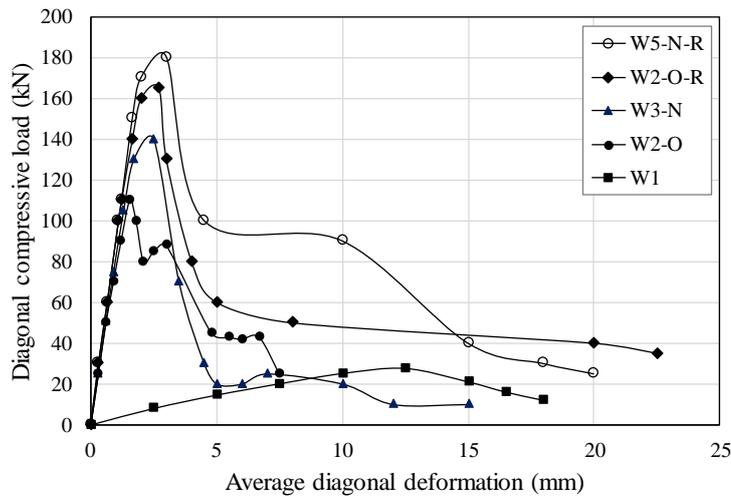
Fig. 6. Diagonal compressive load vs. average diagonal deformation responses.

(equation 3) are summarized in Table 4. The experimental responses in terms of diagonal compressive load versus overall average diagonal deformation (average of L1 and L2) curves are graphically shown in Figs. 6 and 7.

There is a distinct difference between the diagonal compressive load versus overall average diagonal deformation curves of the masonry walls tested in this experimental program both in terms of diagonal compressive load and post peak response. Generally, diagonal compressive load versus diagonal deformation responses of all the tested CCI brick wall specimens were linear up to the ultimate diagonal compressive load. Whereas post peak responses were highly influenced by the presence of cement - sand grout and steel bars. For example, in case of un-grouted CCI brick masonry wall specimen W1, the post peak response indicates a very gradual and linear drop in the diagonal load carrying capacity as shown in Fig. 6. Whereas, post peak response of the wall specimen W2-O is indicating a sudden drop in the diagonal load carrying capacity once the ultimate load was reached. However, the post peak response was not observed truly linear. In case of wall specimen W3-N, initially linear post peak response was observed until 80% drop in the load carrying capacity.

In contrast to the un-grouted and unreinforced CCI brick masonry walls, the post peak responses of the reinforced CCI brick masonry walls were found very stable with a slight decrease in the load carrying capacity and large axial deformation as shown in Fig. 6. This phenomenon can be associated with the presence of steel bars. In the reinforced masonry walls, the steel bars provide sufficient resistance to the crack widening, propagation and sudden drop in load. Therefore, the post peak response of the reinforced masonry walls is much stable as compared with un-reinforced masonry walls.

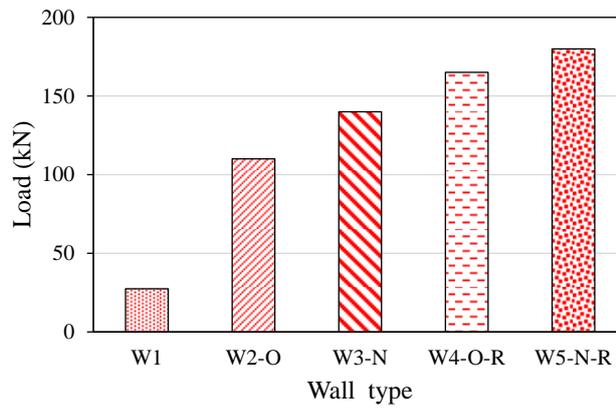
Fig. 7. Ultimate load carrying capacity of walls.

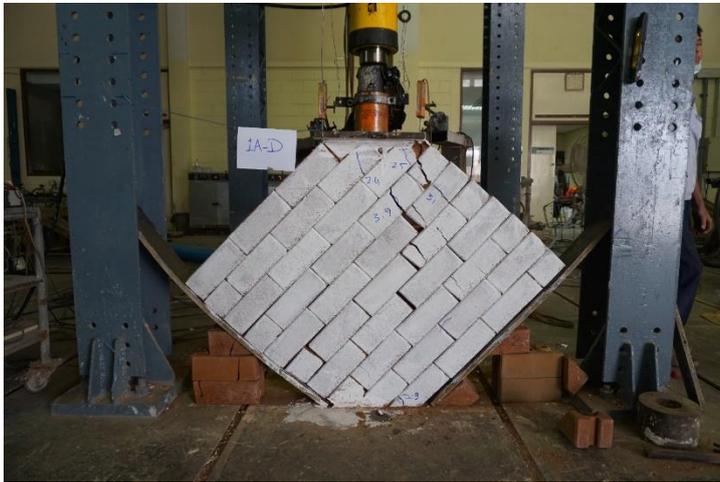
The first visible crack (splitting crack) was observed at the diagonal load of 24 kN under the loading region in the mid location. With the further increase in the load, i.e., at 27 kN, another crack was observed under the loading plate (slightly towards the right side). As the load was increased, i.e., 29 kN, splitting cracks were also noticed at the bottom of the wall, as shown in Fig. 7. As the load was further increased, noticeable sliding of the CCI hollow bricks were observed along the bed joints.

Initiation of the new cracks on the right side was also observed at the diagonal load of 39 kN along with further sliding of the CCI bricks. At this stage, a clear gap of around 1 cm to 2 cm was also noticed between the CCI hollow bricks along the compression diagonal. With the further increase in the load, widening and propagation of the existing cracks along with the crushing of the CCI bricks was noticed. The final failure of the wall specimen W1 was mainly due to the crushing of the CCI bricks (under loading region) and splitting of the CCI bricks (at mid region) as shown in Fig. 8. Based on test observations, the ultimate failure of the wall specimen W1 can be recognized as diagonal tension.

Fig. 8. Failure mode of the wall specimen W1.

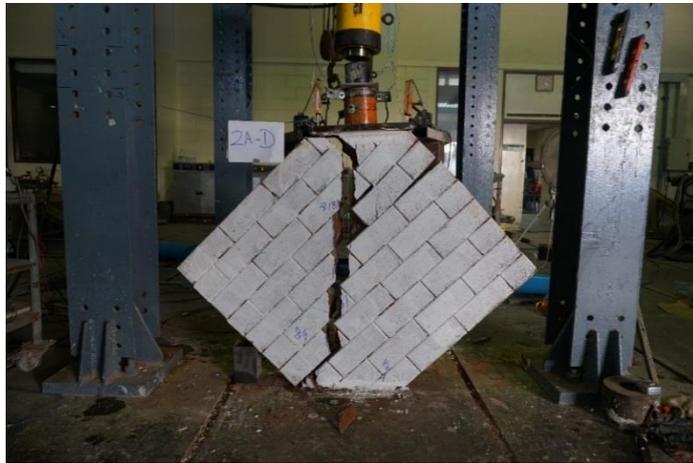
These cracks were initially observed in the middle region of the compressed diagonal, then propagating abruptly towards loading region and bottom of the CCI brick masonry wall. As the load was further increased, i.e., at 84 kN, splitting of the CCI bricks was also observed at left bottom of the CCI brick masonry wall. The further increase in the load resulted in the widening and propagation of the existing vertical cracks in the middle of the wall. The final failure of the wall specimen W2-O, was mainly due to the splitting of the CCI bricks along the compressed diagonal, sliding of the CCI brick along the bed joint (at bottom region) and crushing of the CCI bricks under loading region and at the bottom of the CCI bricks.

At the ultimate stage, a clear and wide gape (up to 5 cm) was observed at the compressed diagonal as shown in Fig. 9. Previous experimental studies conducted on the diagonal compressive response of block masonry walls [40] have also shown similar kind of failure modes. The ultimate mode of the wall specimen W1 can be recognized as splitting failure.

Fig. 9. Failure mode of the wall specimen W2-O.

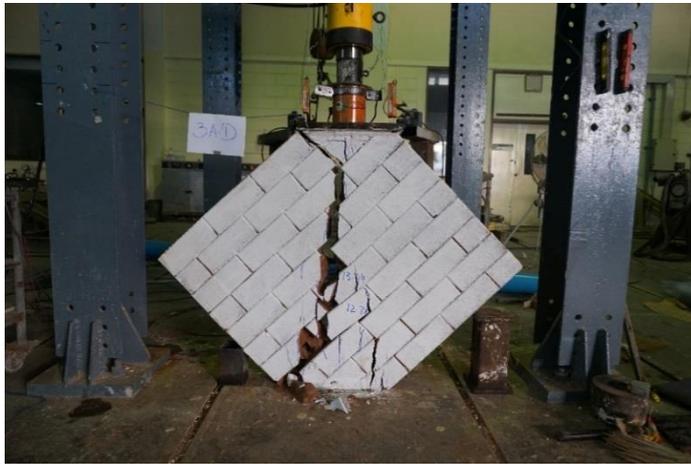
In the masonry wall specimen W3-N, the first crack was also developed at the bottom of the masonry wall, following a sudden and abrupt initiation of the vertical crack at compression diagonal similar to the wall specimen W2-O. Few more cracks were also appearing in the middle region at the next loading step i.e., 134 kN. The further increase in the load was resulted in the widening and propagation of the existing cracks along with the development of few more cracks in the lower middle of the wall.

At this stage sliding of the CCI hollow bricks along the bed joints were also observed in the mid of the diagonal compression. The final failure of the wall specimen W3-N, was mainly due to the splitting of the CCI bricks along the compressed diagonal, sliding of the CCI brick along the bed joint (at the bottom region) and crushing of the CCI hollow bricks under loading region and at the bottom of the CCI bricks. Similar to the wall specimen W2-O, a clear and wide gape (up to 5 cm) was observed at the compressed diagonal as shown in Fig. 10. In this wall specimen, large number of splitting cracks were also observed at the bottom of the wall prior to the final failure. The ultimate mode of the wall specimen W3-N can be recognized as splitting failure and diagonal tension failure.

Fig. 10. Failure mode of the wall specimen W3-N.

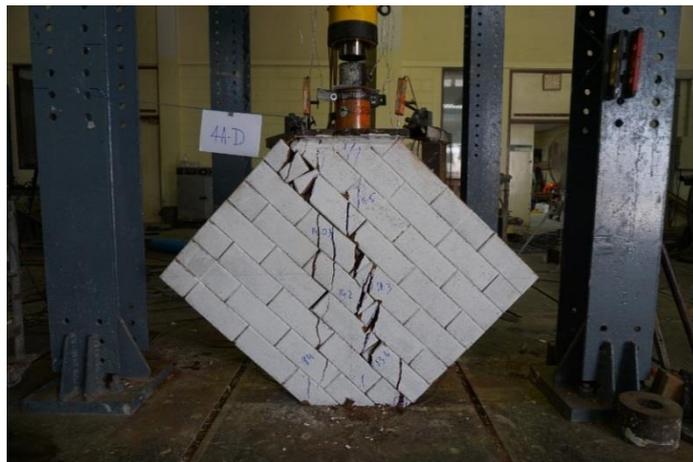
Afterward, large lateral dilation and crack widening were observed at the diagonal load of 150-150 kN along with the appearance of several hairline inclined cracks at different locations (mainly at the bottom and under the loading region). The final failure of the wall specimen W4-O-R, was mainly due to the splitting of the CCI bricks along the compressed diagonal, sliding of the CCI brick along the bed joint (under the loading and at bottom region) and crushing of the CCI bricks at different locations along the compression diagonal as shown in Fig. 11.

The final failure of wall specimen W4-O-R was very ductile as compared with the unreinforced masonry walls i.e., W2-O and W3-N. The ultimate failure mode of the wall specimen W4-O-R can be recognized as a combination of shear slip along the bed joints and diagonal tension.

Fig. 11. Failure mode of the wall specimen W4-O-R.

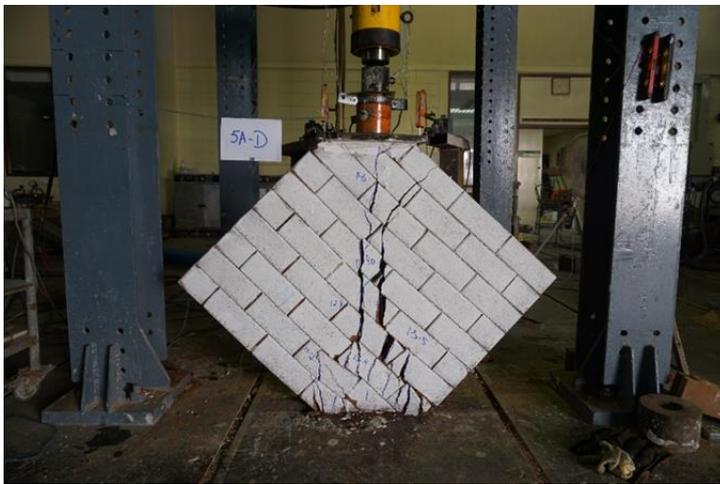
As the load was further increased, i.e., at 124 kN, the propagation of the main crack was also observed towards the bottom region of the masonry wall. The further increase in the load was resulted in the widening and propagation of the existing cracks along with the development of few more cracks in the lower middle of the wall. Similar to the wall specimen W4-O-R, there was found delay in the crack widening and propagation after the development of initial cracks due to the presence of steel bars. Afterword, large lateral dilation and crack widening were observed at the diagonal load of 150-150 kN along with the appearance of several hairline inclined cracks at different locations (mainly at the bottom location).

The final failure of the wall specimen W5-N-R, was mainly due to the splitting of the CCI bricks along the compressed diagonal, sliding of the CCI brick along the bed joint (at the bottom region) and crushing of the CCI bricks at different locations along the compression diagonal as shown in Fig. 12. The final failure of wall specimen W5-N-R was very ductile as compared with the unreinforced masonry walls i.e., W2-O and W3-N. The ultimate failure mode of the wall specimen W5-N-R can be recognized as a combination of shear slip along the bed joints and diagonal tension.

Fig. 12. Failure mode of the wall specimen W5-N-R.
