## **IMPLEMENTATION OF UAV LIDAR FOR SURVEYING PAVEMENT CONDITIONS COVERED BY DIFFERENT VEGETATION DENSITIES**

This study examines the effectiveness of UAV LiDAR technology in surveying road pavement conditions in areas with varying vegetation densities, a significant challenge in tropical environments like Indonesia. High vegetation density along roadsides obscures damage detection, limiting UAV LiDAR's application. This research was conducted along a 200-meter road segment in Bandung, West Java, Indonesia, with areas classified by vegetation density into sparse (0-35%) and dense (>70%) categories. UAV LiDAR captured data efficiently in sparse vegetation zones, but its effectiveness decreased in dense coverage areas, missing critical damage indicators. To address these limitations, we also employed a SLAM Scanner, which, unlike UAV LiDAR, operates flexibly under dense vegetation. The SLAM Scanner results closely aligned with manual survey data, achieving a 94.61% similarity, compared to 86.52% for UAV LiDAR. Although UAV LiDAR reduced survey time and costs, SLAM Scanner proved more reliable for dense vegetation zones, achieving higher detection rates for various road damages. Thi

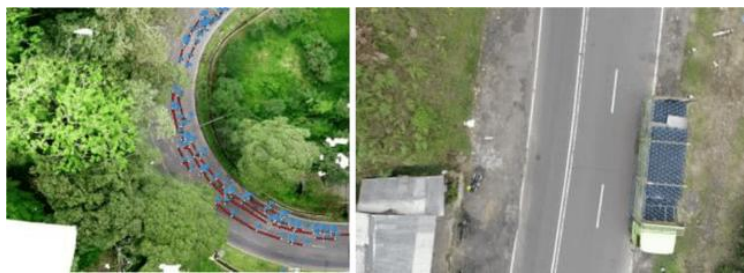
**Fig. 1. Survey results using UAV covered by trees and vehicles.**

Tamansari Road in Bandung City, West Java, Indonesia, has dense roadside vegetation with a density of 83.57%, making the road pavement difficult to observe using UAVs. Although UAV technology is increasingly used for road surveys, it has limitations in detecting damage in areas with high vegetation density [11, 12], as shown in Fig. 1. Vegetation along roadsides is classified into Open (0%), Sparse (<35%), Moderate (35-70%), and Dense (>70%) categories [13].

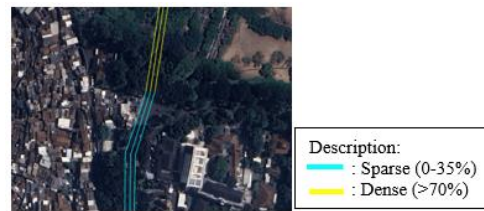
**Fig. 2. Vegetation density classification on Tamansari Road.**

patching and edge cracks, was observed, and vegetation density was classified (Fig. 2). A manual road condition survey followed, using SDI and PCI methods, with sample units divided into 50-meter sections for PCI and 100-meter segments for SDI [23, 24].

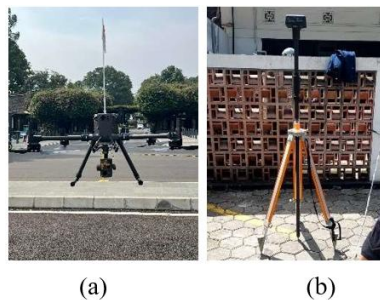
**Fig. 3. UAV LiDAR survey equipment: (a) DJI Matrice 300 RTK UAV and DJI Zenmuse L1 LiDAR Payload, (b) DJI DRTK 2 Geodetic GPS.**

For the UAV LiDAR survey, tools like the DJI Matrice 300 RTK UAV, Zenmuse L1 LiDAR payload, and DRTK 2 GPS were used (Fig. 3). Flight missions were conducted at 70 meters (45° angle) and 100 meters (90° angle) at 3 m/s. Collected point cloud data were processed into a Digital Terrain Model (DTM), excluding non-terrain features, and a Digital Surface Model (DSM), which includes all surface details (Fig. 4).

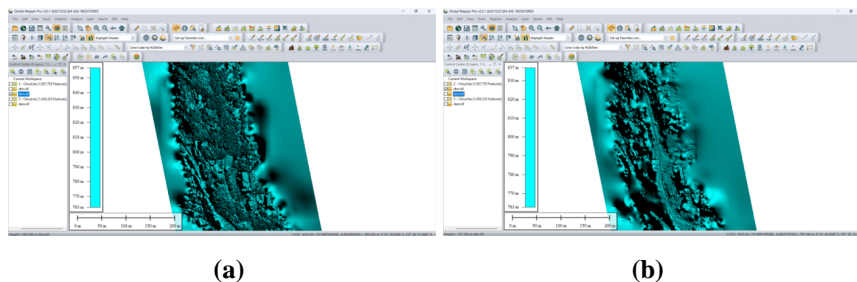
**Fig. 4. Processing data (a) DSM, (b) DTM.**

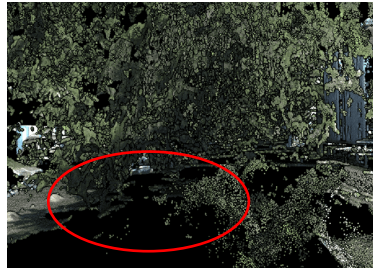
**Fig. 5. The road beneath the vegetation was not captured by UAV LiDAR between STA 0+100 and STA 0+150.**

UAV LiDAR proved unsuitable for surveying roads covered by vegetation, as it could not detect roads obscured by trees (Fig. 5). To address this, a more flexible

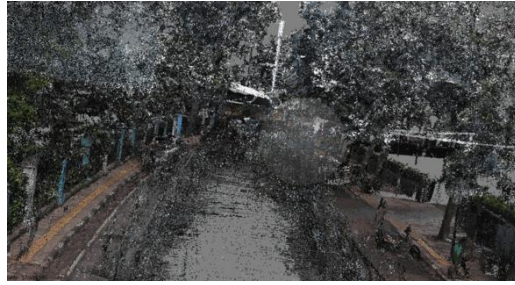
**Fig. 8. Display of registration results.**

After data collection, processing involves registration, filtering, and meshing stages using software like GOpot and Microstation to refine the data for visualization. Figure 8 shows the results of the registration.

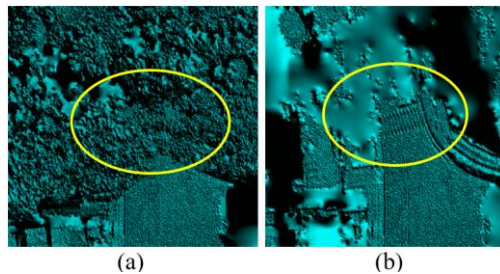
**Fig. 9. UAV LiDAR's capability to penetrate sparse vegetation, (a) Before filtering, (b) After filtering.**

Processed data from the UAV LiDAR and SLAM Scanner surveys were used to identify road damage. UAV LiDAR struggles with detecting damage in dense vegetation but can identify features in areas with sparse cover, as shown in Fig. 9.

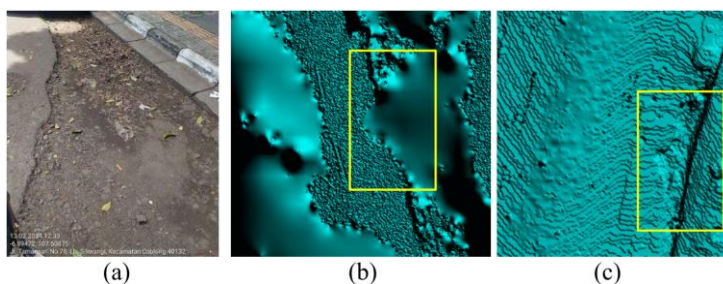
**Fig. 10. Captured results of edge crack damage, (a) Field condition, (b) UAV LiDAR, (c) SLAM scanner.**

On Tamansari Road, only medium to high severity patching and edge cracks were detected, while other minor damages were not captured by either tool. SLAM Scanner successfully identified patching damage that UAV LiDAR missed due to vegetation obstructions (Figs. 10 and 11).

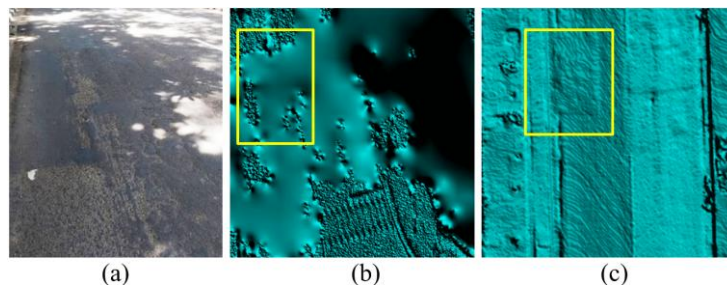
**Fig. 11. Captured results of patching damage,**  
(a) Field condition, (b) UAV LiDAR, (c) SLAM scanner.
