EFFECT OF OPENING CHARACTERISTICS ON THE PERFORMANCE OF HIGH STRENGTH RC DAPPED-END BEAMS

**QASIM M. SHAKIR*, HAIDER ALI AL-TAMEEMI
HAYDER H. H. KAMONNA**

Civil Engineering Department, University of Kufa, Najaf, Iraq
*Corresponding Author: qasimm.alabbasi@uokufa.edu.iq

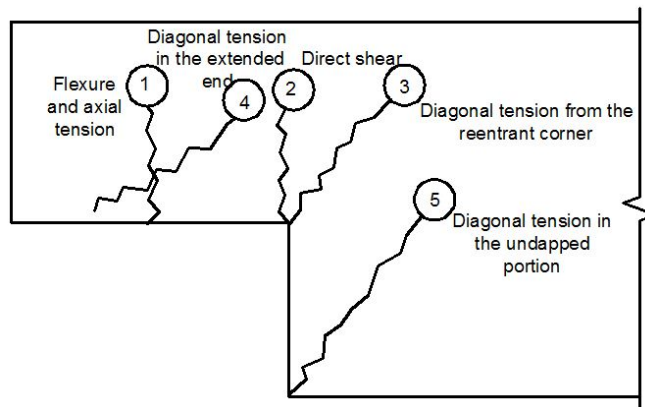
Fig. 1. Failure modes for the dapped end beam [2].

Based on available previous investigations, the failure of the D-EBs is expected to occur at the nib (extended end), the junction between of the nib and the main body, re-entrant corner, or bottom corner of the full-depth part of the dapped-end [2] as shown in Fig. 1. A number of researches have been conducted to investigate the behaviour of D-EBs. Mattock and Chan [3] proposed a rational and modified design procedure for D-EBs considering the dapped ends as an inverted corbel following the design proposal of Mattock [4]. They recommended that a group of closed stirrups should be provided near the full-depth beam and all reinforcements should be well anchored.

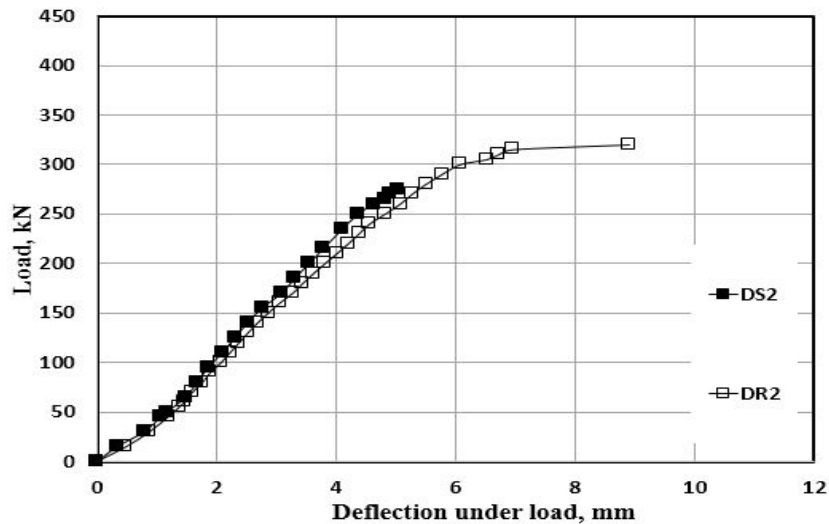
Fig. 7. Load-deflection curves for specimen DR2 against DS2.

Figure 7 shows the load-deflection curve of specimen DR2 against that of specimen DS2. It is noted that the failure load of specimen DR2 was greater than that of specimen DS2. That can be explained by the cracking path directed toward the corners of the opening, which played a major role in the failure modes of both these two specimens, was larger and it was interrupted by more shear reinforcement in specimen DR2.

In the same time, it is clear that the response of DR2 was softer than that of DS2 that can be due to the opening size is larger in the specimen DR2. Furthermore, at the interval of loading 300-322 kN of DR2, some instability in response can be seen revealing that severe local failure occurred subsequently in two points around the opening leading to a sudden failure of the specimen at the load of 322 kN.

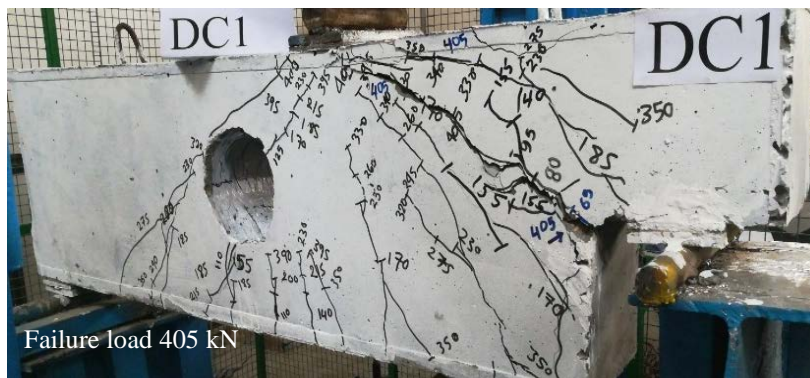
Fig. 9. Crack pattern for specimen DC1.

Figures 8 to 10 show the crack patterns of specimens D00, DC1 and DS1. It can be observed that the load capacity of the solid beam D00 is smaller than the capacities for the specimens DS1 and DC1. This may be attributed to the bent in the main nib reinforcement, which was needed to accommodate the openings. This may result in an enhancement in performance of the dapped end rather than to be straight as in the conventional form. The improvement in behaviour may be attributed to the fact that the bending of nib reinforcement may produce three different effects. It may produce better integrity between the upper part of the beam (including the dapped end) and the lower part leading to higher resistance to cracking penetration and propagation. Furthermore, the bent makes the bars within the dapped end to act

as frames. Thus, more resistance to bending will be gained. In addition, the bent bars result in some enhancement in the hanger zone as reported previously by Leim [5]. In general, for the three specimens, the diagonal shear cracking was dominant. Figures 9 and 10 state that the diagonal cracking developed mostly, out of the opening zone. Thus, making the opening to be inactive.

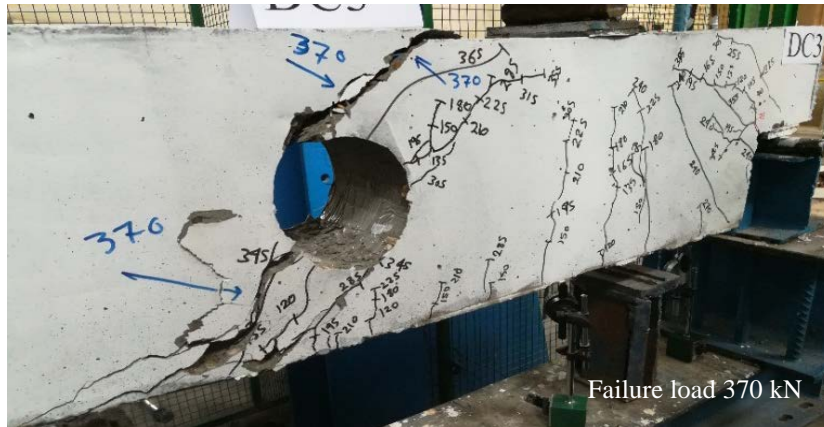
Fig. 12. Crack pattern for specimen DC3.

Comparing specimens DC2 with DC3, in which, the pattern is shown in Fig. 12, it can be seen that the crack patterns are identical for all stages of loading. It is clear that the cracking emanating from the circular opening followed a diagonal path and it was restricted from widening by the stirrups. However, for specimen DC3, due to the vicinity of opening from the left support, some cracking developed diagonally toward this support. Thereby dapped end could counteract more curvature than the dapped end of beam DC2. Hence, cracks that developed from the opening to the loading point and the support produced a weak zone at the opening, which acts as a plastic hinge. This made the beam to deflect as two segments and caused spalling near the loading point, which led to the formation of a sudden crack with the area above the opening. This crack resulted in a drastic drop in shear strength. Thus, the mode of failure changed at the last stage of loading to be as a diagonal shear failure through the opening. It can be concluded that disregarding opening details in the design may lead to an unexpected failure mode.

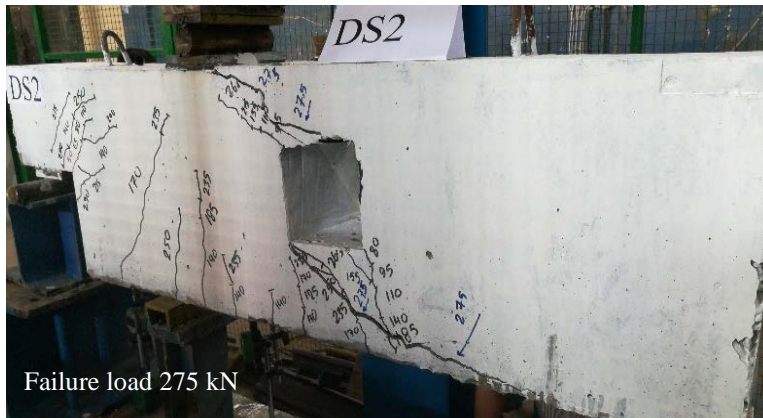
Fig. 13. Crack pattern for specimen DS2.

For specimen DS2, the crack pattern is shown in Fig. 13. Comparing DS1 with DS2, it can be seen that in DS2, the opening is shifted to the non-dapped end within the shear zone. Cracks emanated at the opposite corners of opening in the direction of the line passing from loading point toward left support. The test was terminated by diagonal shear failure through the opening.

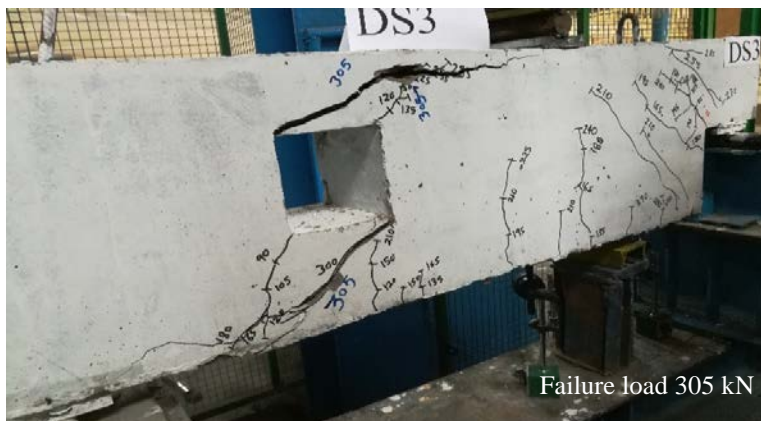
Fig. 14. Crack pattern for specimen DS3.

It can be seen that specimen DS3, in which, cracking pattern is shown in Fig. 14, resisted more load than specimen DS2. This may be attributed to the fact that DS3 includes more stirrups interrupting the crack initiated from the top corner and developed towards the point load. With loading progress, cracks propagated at the dapped end and from the bottom corners of opening towards the support. This resulted in more curvature. Subsequently, a spalling of the top layer of concrete has taken place. As a result of the difference in the number of stirrups, the failure of DS3 was delayed.

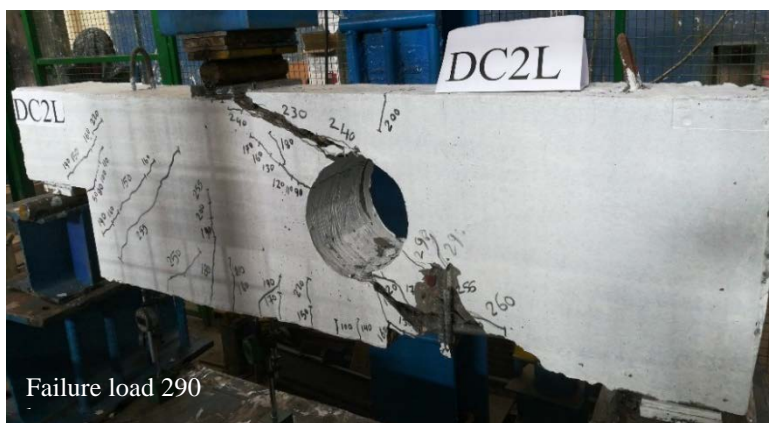
Fig. 15. Crack pattern for specimen DC2L.

Figure 15 shows the cracking pattern for the specimen DC2L. It can be seen that the mode of failure is similar to that of specimen DC3. This may be attributed to the reduction in the top and lower chords of the opening, which results in more weakness in the opening zone rather than the dapped end zone as in specimen DC2. Therefore, it can be concluded that locating openings with larger size within the zone of small shear may result in similar behaviour as for smaller openings located within zones of high shear.

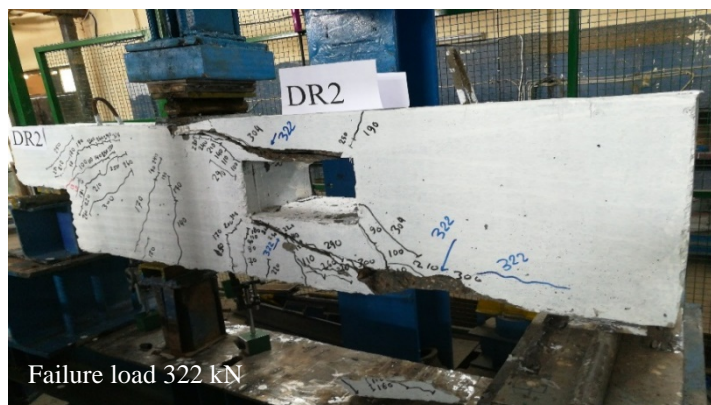
Fig. 16. Crack pattern for specimen DR2.

Figure 16 shows the crack pattern for specimen DR2. It is clear that the failure mode of this specimen is a diagonal shear failure through the opening. The improved capacity may be due to the shifted stirrups to both sides of the opening leading to a higher shear resistance than DS2. Remembering that the top chord failed before the bottom due to the crushing. The failure occurred at two stages of loading. The first occurred at top chord within load level of 300 kN followed by collapse at 322 kN. Thus, it is recommended to substitute the stirrups within the opening location by stirrups on both sides of the opening.

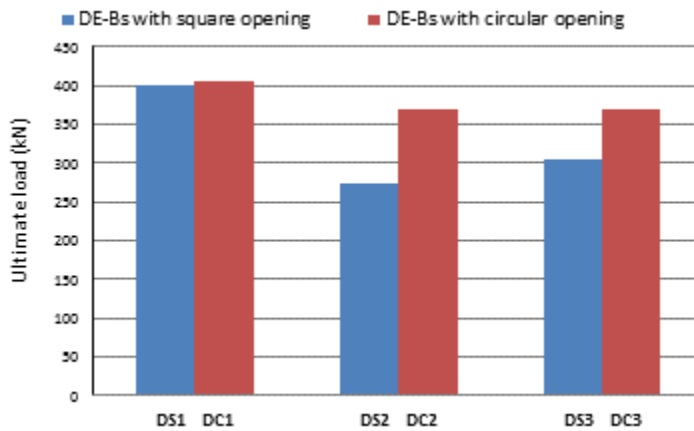
Fig. 17. Effect of the opening location on load capacity of the dapped end beams.

Figure 17 shows the effect of the opening located on the DE-Bs capacity. It can be clearly noticed that the specimen DS1 and DC1 recorded the highest capacity compared with other cases and the failure occurred at the dapped ends rather than the opening. Therefore, introducing the opening has the lowest effect. The reason for that may be due to locating the opening in the maximum moment region and this discussion previously presented. It can also be noticed that when the opening displaced to the second position ($x = 375$ mm) therefore, there is a possibility that the expected strut may be interrupted by the opening. This resulted in a drop in

capacity of about 31% and 8% in case of D-EBs with square and circular opening respectively compared with the case of D-EBs with the opening located at high bending moment zone. The ultimate capacity slightly increased for DS3. This may be attributed to the longer crack path, which requires higher energy to be developed.
